Environmental Health Inspections
East Mississippi Correctional Facility
Meridian, Mississippi
June 1, 2016 through June 2, 2016

December 19, 2016

Prepared by:
Diane Skipworth, MCJ, R.D., L.D., R.S., CCHP, CLLM

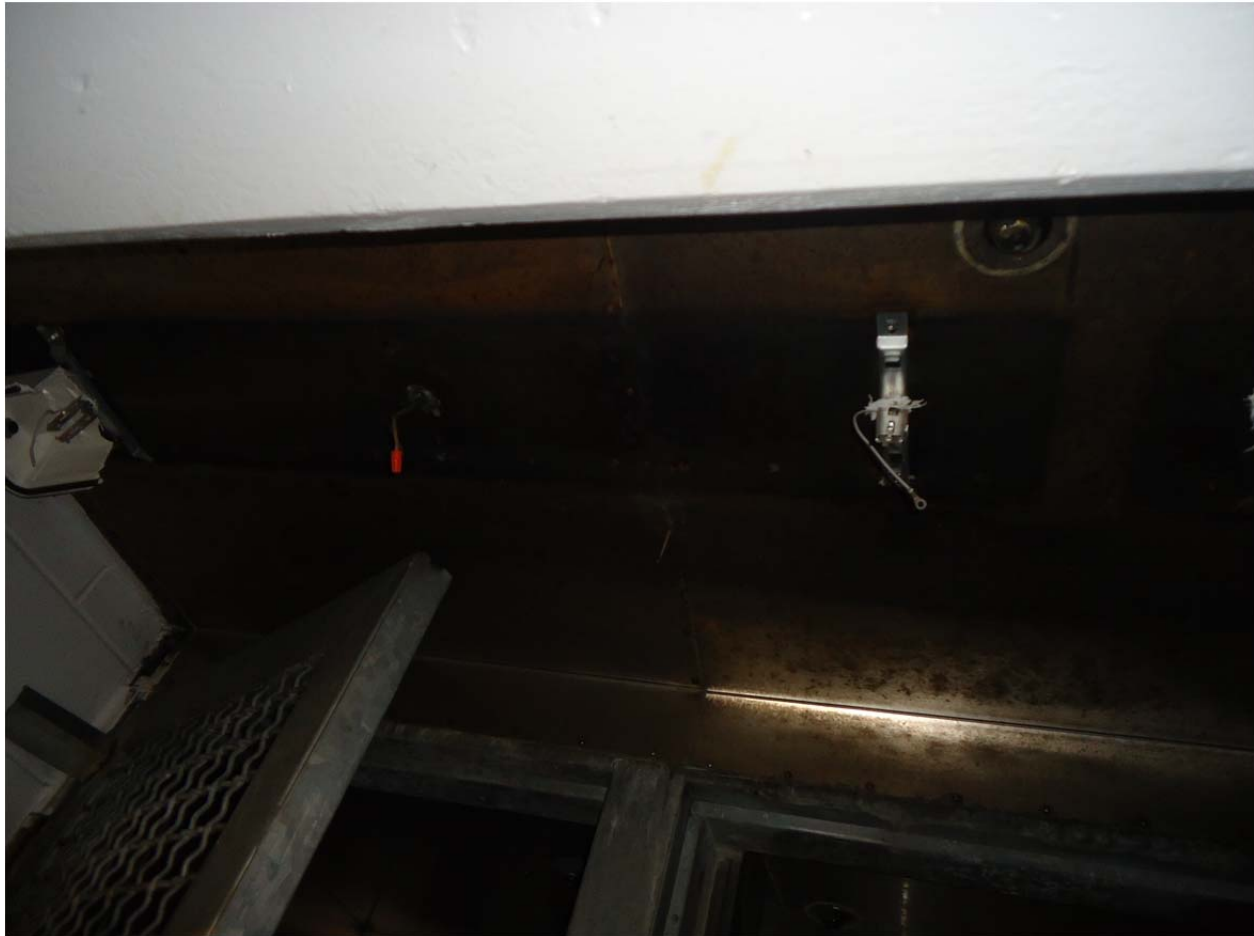
Photo Exhibit: 1

Housing Unit 5B – Lower Showers: Photo of the lower level shower area in 5B. The picture was taken from outside the shower stalls and the open door is one of three individual shower stall doors. The exposed wires and orange wire nut pinpoint the location of the missing light fixtures. Exposed electrical wires place inmates at risk of electrical shock. The picture also illustrates the poorly illuminated environment, as even with the camera flash, it is still extremely dark. Light meter readings taken on 6-2-16 were 0.11 foot-candles in the center and left stalls and 0.5 foot-candles outside the stalls, well below the minimum 20 foot-candles in washrooms, as required by APHA standards. The dark environment creates safety hazards as the dim lighting limits the ability of custody staff to monitor the area, prisoners may be subject to slips and falls in the dimly lit area, the showers and floor may not be properly cleaned and disinfected because those conducting the cleaning may have difficulty seeing dirt and mildew, and prisoners may neglect their personal hygiene by electing to not shower due to safety concerns created by the lack of light.

5B	Lower Showers	Missing light fixture - Photo Exhibits 1 and 2
5B	Upper Showers	Only 1 of 2 light fixtures working
5B	Cell 105	No bulb observed
5B	Cell 114	No bulb observed - Unoccupied cell
5C	Cell 114	No bulb observed
5D	Lower Showers	Missing bulb and wires hanging out of fixtures
5D	Upper Showers	Light fixtures not operable - Photo Exhibits 3 and 4
6A	Lower Showers	No bulbs observed and stall doors would hit bulbs if present
6A	Cell 110	No bulb observed
6B	Lower Showers	No bulbs observed and stall doors would hit bulbs if present Photo Exhibits 5 and 6
6B	Upper Showers	No bulbs observed
6B	Cell 107	No bulb observed - Unoccupied cell
6C	Lower Showers	Very dimly lit and no bulbs observed
6C	Cell 106, 111	No bulb observed
6D	Cell 105	No bulb observed

The failure to properly maintain the lighting fixtures throughout EMCF creates safety hazards, including a risk of burns, electrical shock (Photo Exhibits 1 and 11), and exposure to broken glass (Photo Exhibits 5 and 6). Furthermore, failing to maintain lighting that complies with the minimum illumination standard creates an environment in which prisoners may be more likely to slip on wet floors or trip and fall in the dimly lit shower areas. Additionally, the broken and missing floor tiles in the kitchen (Photo Exhibits 17 and 23) create an uneven surface that increases the likelihood of tripping or falling. Therefore, failing to maintain sufficient, operable lighting and the poor condition of the kitchen flooring places prisoners and employees at increased risk of accidental injuries.

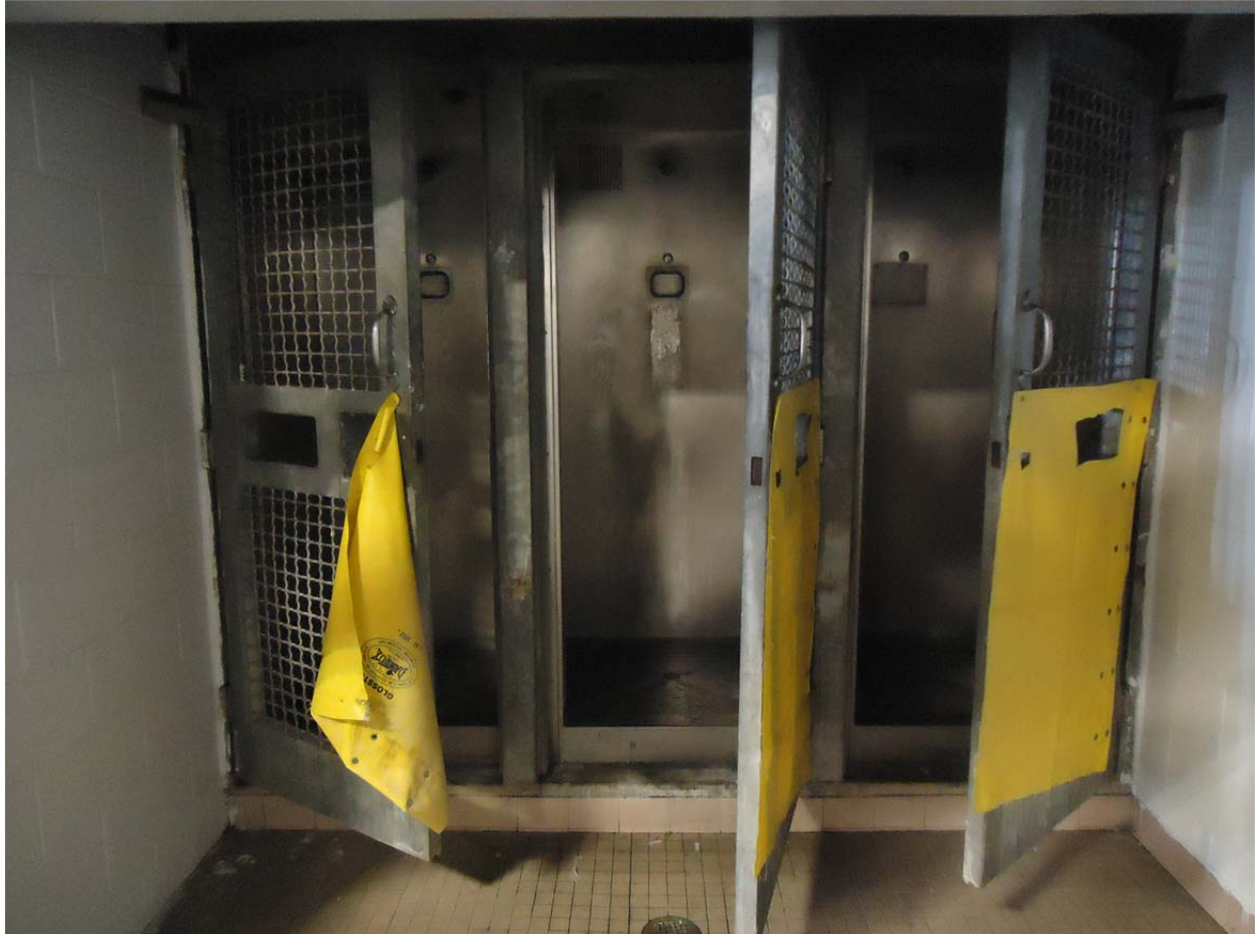
Photo Exhibit: 2

Housing Unit 5B – Lower Showers: Photo of the lower level shower area in 5B. The camera flash was more effective in this photo than it was in Photo Exhibit 1. However, the dark and shadowy environment in the shower stalls, created by the missing light fixtures, can still be observed even with the camera flash. This picture also illustrates the doorstops welded on the upper hinge side of the two end shower stall doors. The doorstops hit the cinder block wall and prevent the doors from fully opening. The end doors appear to be as far open as the doorstops will allow. Although the doorstops may help prevent damage to the walls and light bulbs, they present a safety hazard in the event that a prisoner should need to be extricated from one of the shower stalls in a medical emergency. Additionally, prisoners may trip and fall on the low ledges, especially in dimly lit shower areas.

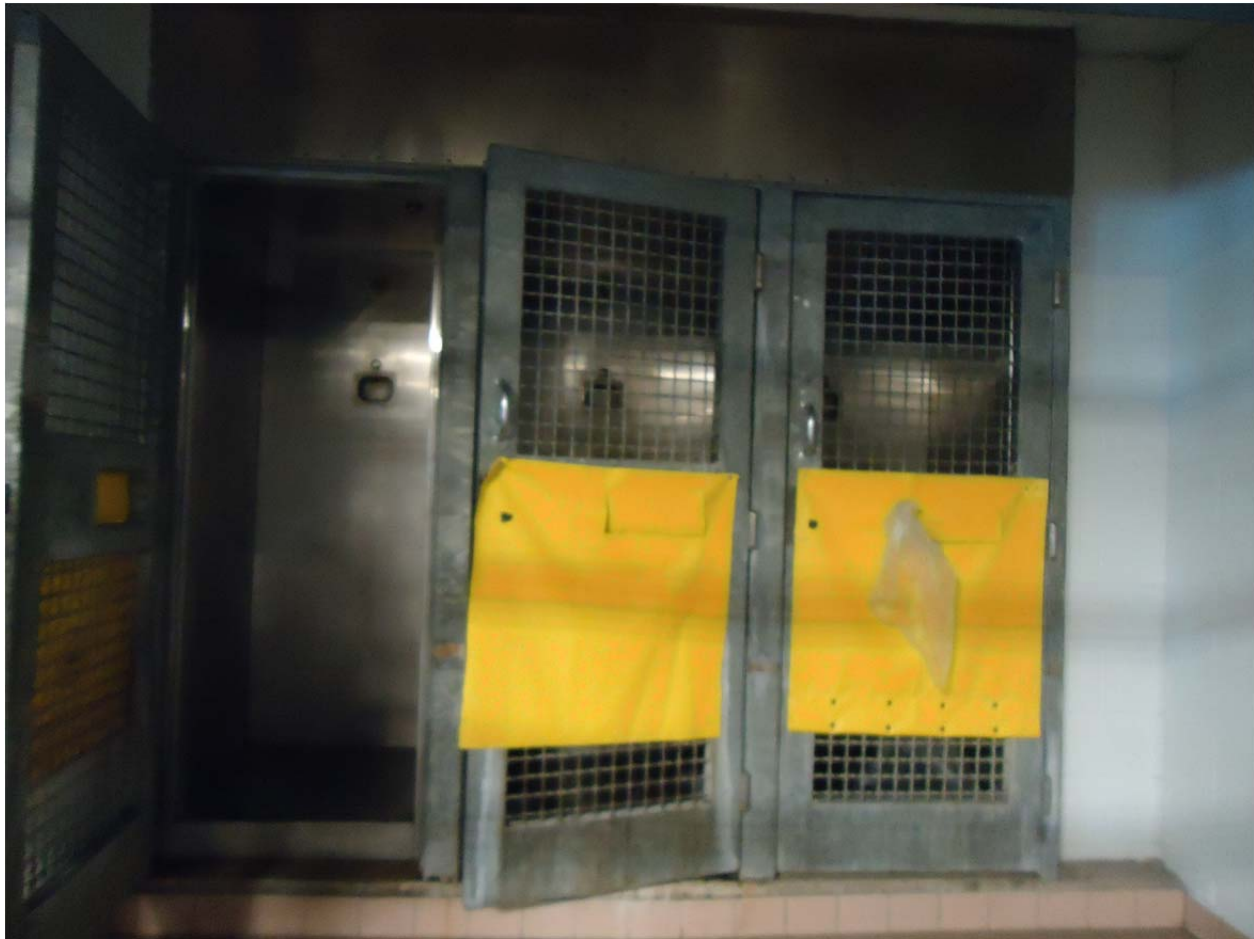
Photo Exhibit: 3

Housing Unit 5D: Photo of 5D upper shower area. The illumination level in this area was measured at 0.5 to 2.4 foot-candles, far below the minimum 20 foot-candles in washrooms, as required by APHA standards. The interior of the shower stalls was quite dark; the picture appears better illuminated because of the reflection of the camera flash on the stainless steel shower stall walls. The upper showers have a greater distance between the shower door and the ceiling and therefore do not have doorstops, allowing the doors to fully open, as compared to the door opening in Photo Exhibit 2. The lighting deficiency creates an environment that is not conducive to personal hygiene, sanitation, safety, or security.

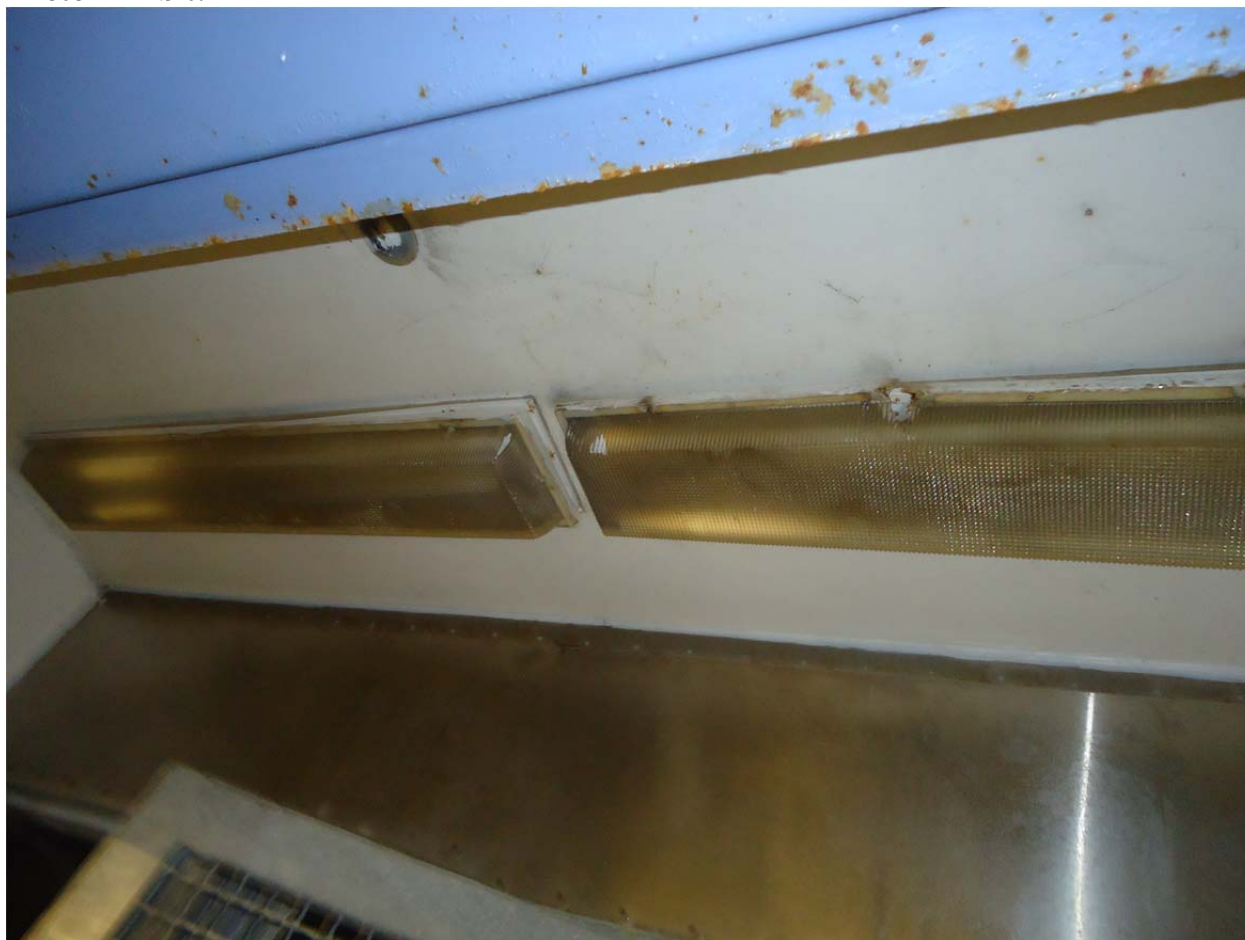
Photo Exhibit: 4

Housing Unit 5D: This photo depicts the non-functioning light fixtures in the unit 5D upper shower area. The illumination level under these fixtures was 2.4 foot-candles, far below the minimum 20 foot-candles in washrooms, as required by APHA standards. The lighting deficiency creates an environment that is not conducive to personal hygiene, sanitation, safety, or security.

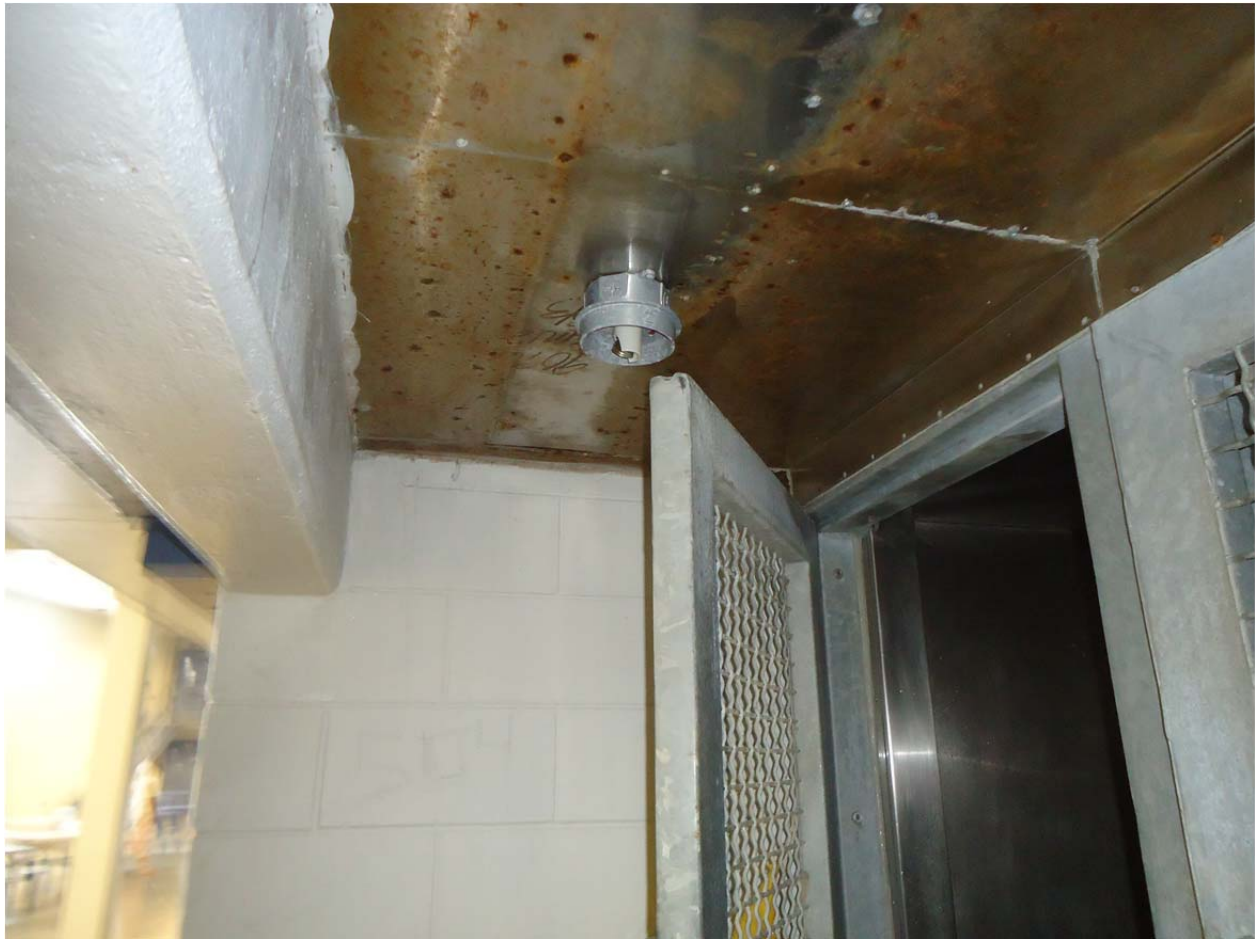
Photo Exhibit: 5

Housing Unit 6B: Picture of the 6B lower shower area. The actual illumination levels were measured at 0.23 foot-candles in the right shower stall and 1.0 foot-candles outside the stalls, well below the minimum 20 foot-candles, as required by APHA standards. This condition creates an obstacle to personal hygiene, sanitation, safety, and security. This picture also depicts the single bulb style light fixture and proximity to the swinging shower stall door. If a light bulb were installed, the normal swing of the door would break it.

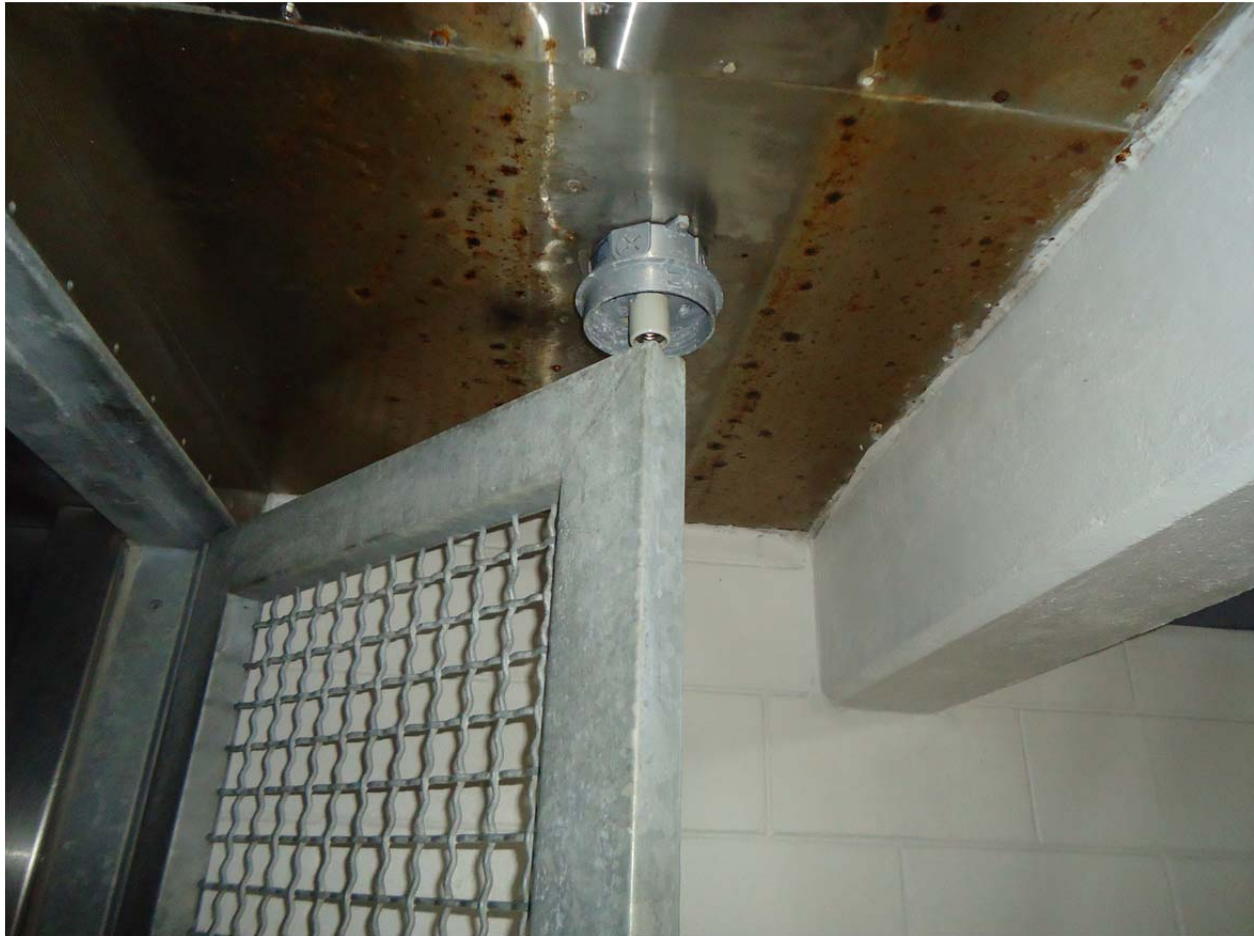
Photo Exhibit: 6

Housing Unit 6B: Picture of the 6B lower shower area. This picture illustrates the juxtaposition of the single bulb style light fixture and the shower stall door and clearly demonstrates that if a light bulb were installed, the swing of the door during opening and closing would break it. The failure to fix this problem means that the light fixtures are unusable and creates a dangerously dark environment as the light levels were measured at 0.23 foot-candles in the right shower stall and 1.0 foot-candles outside the stalls, far below the minimum 20 foot-candles required by APHA standards.

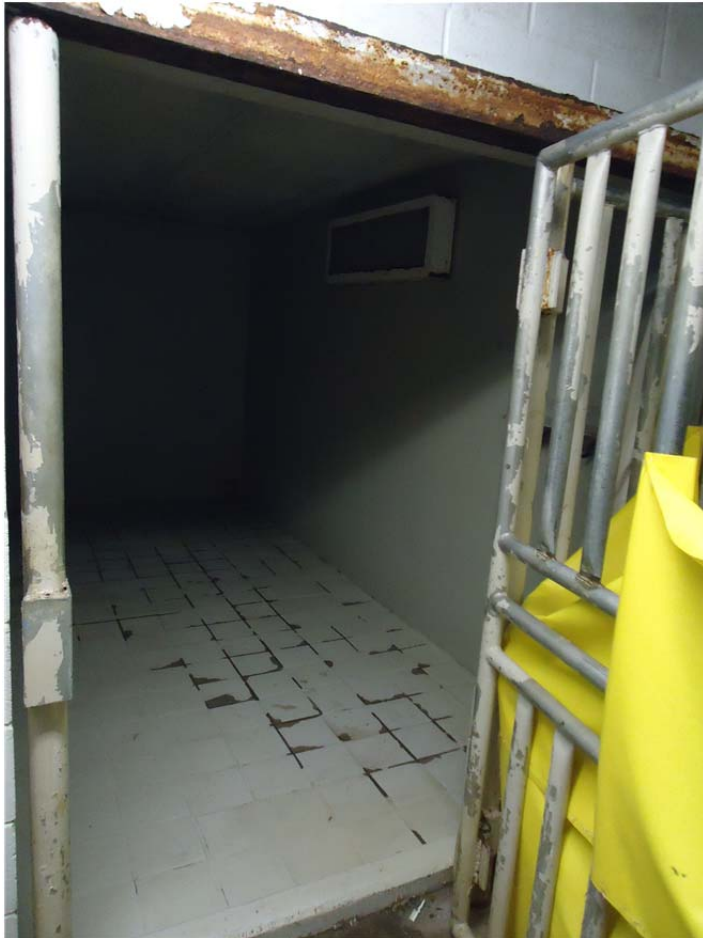
Photo Exhibit: 7

Housing Unit 4C: Photo of upper tier shower room in housing unit 4C. The light fixture can be seen on the upper portion of the wall on the right side of the picture. However, the light fixture was not illuminated resulting in a dimly illuminated environment with light meter reading of 0.14 to 5.7 foot-candles, far below the far below the minimum 20 foot-candles, as required by APHA standards. The lack of sufficient illumination hinders good personal hygiene, sanitation, safety, and security.

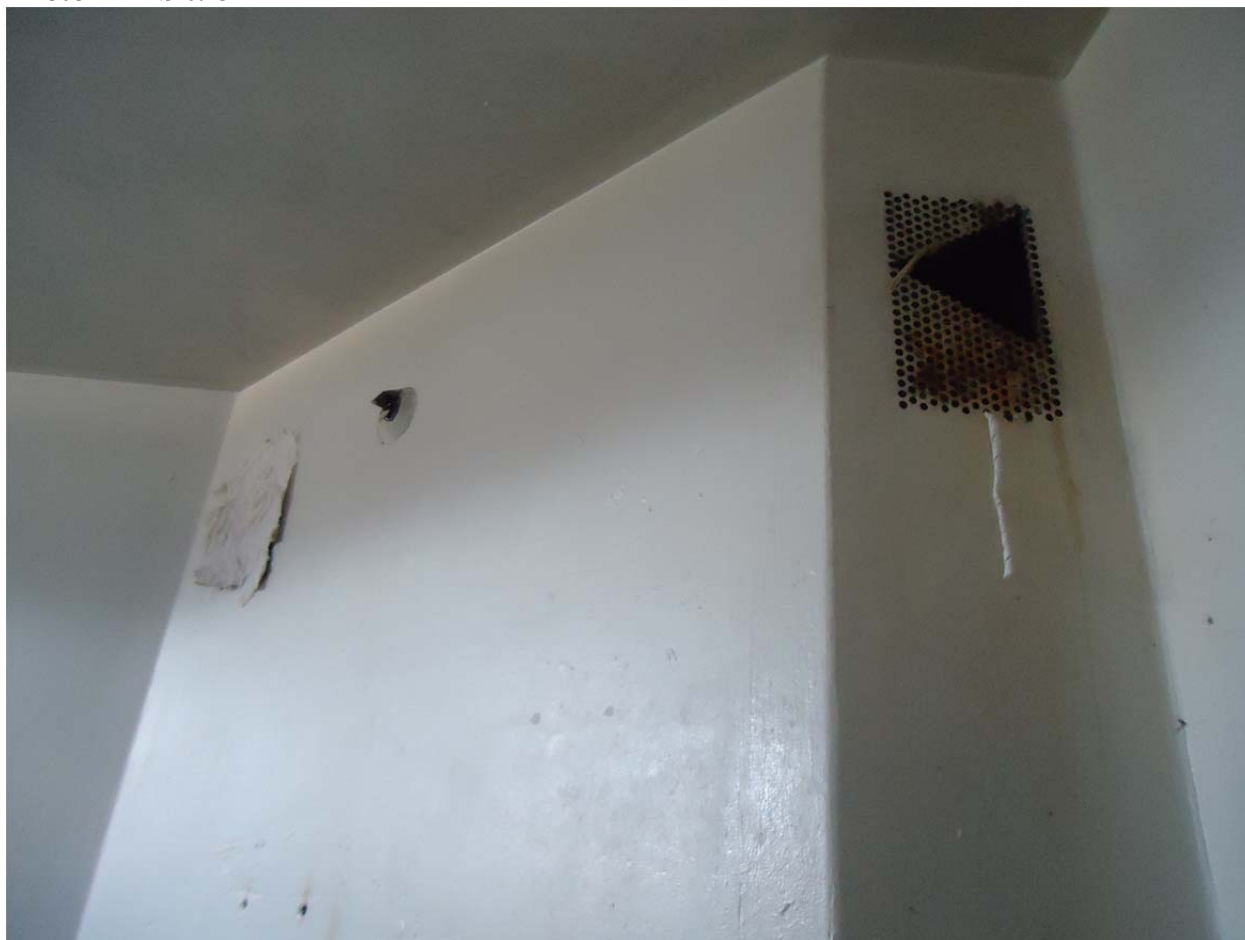
Photo Exhibit: 8

Housing Unit 6C: Ventilation grille in Cell 202 blocked by a piece of paper on the left side of the photo and two “wicks” extending from the intake air vent on the right side of the photo. The strong odor of smoke was discernible throughout the housing units, and was especially strong in housing units 5 and 6. The prevalent smoke odor combined with the observations of smoldering and burned items throughout the housing units clearly indicates inadequate fire safety practices at EMCF, placing inmates and officers at serious risk of fire related injury.

The distinct odor of smoke was prevalent throughout the housing areas, and was particularly noticeable in Units 1, 4, 5, and 6. Wicks and evidence of burned and scorched items were observed in numerous housing locations (Photo Exhibits 8, 9, 10, 12, 13, and 14). The practice of placing smoldering wicks in the ventilation grilles introduces contaminants and circulates smoke through the HVAC system (Photo Exhibit 8). Additionally, a very strong odor of cigarette smoke was predominant in Unit 4 and ashes that resembled those from a cigarette were observed in a metal container on a dayroom table in Unit 4A. The seemingly recurrent incidence of smoke generation poses health risks, particularly to individuals with respiratory illnesses.

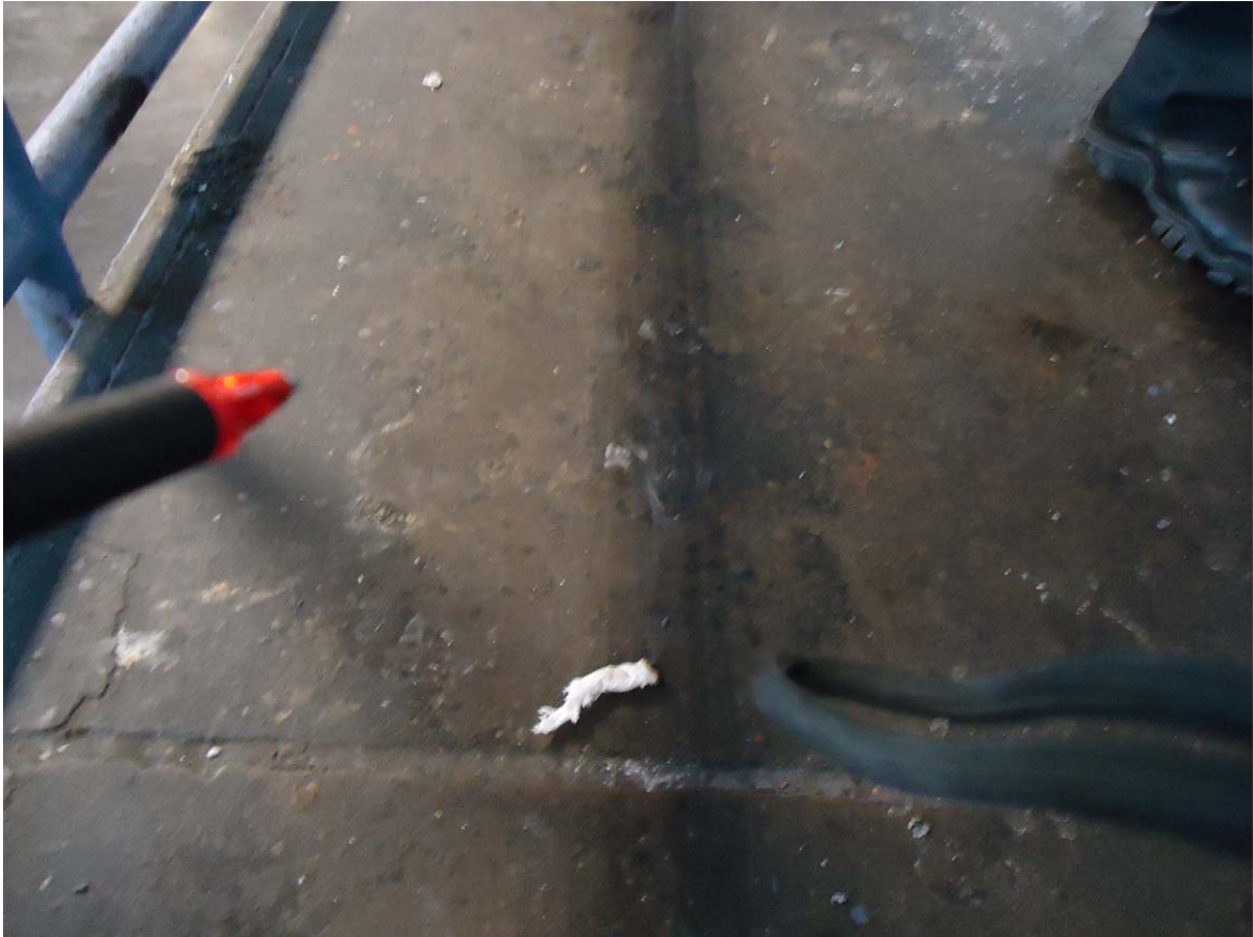
Photo Exhibit: 9

Housing Unit 5A: The photo depicts a smoldering wick on the floor near cell 207. When examined closely, the right side of the wick is blackened from burning and smoke can be seen swirling out it. A strong smoke smell permeated the housing unit and numerous cell doors were soiled with soot from previous fires. Fire and smoke inside a correctional facility presents a serious danger to both inmates and employees.

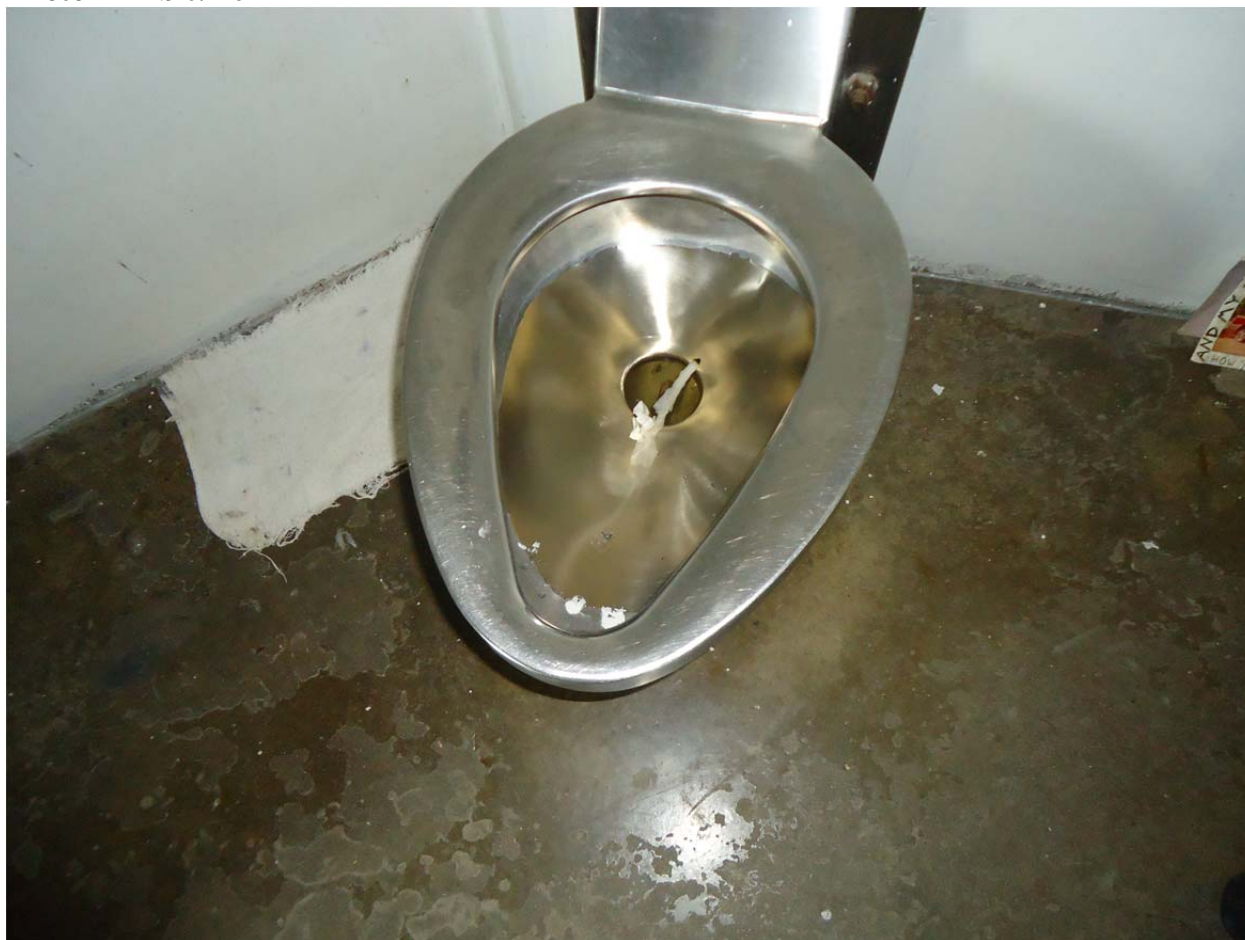
Photo Exhibit: 10

Housing Unit 1A: The photo depicts a wick in the toilet in cell 105. One end of the wick is blackened from burning. This cell appeared to be the origin of the heavy, strong smoke odor that permeated unit 1A. Furthermore, the cover of the light fixture in this cell was pulled away from the wall and the electrical wiring had been pulled loose as depicted in Photo Exhibit 11. Prisoners often use exposed electrical wiring to create sparks and light wicks.

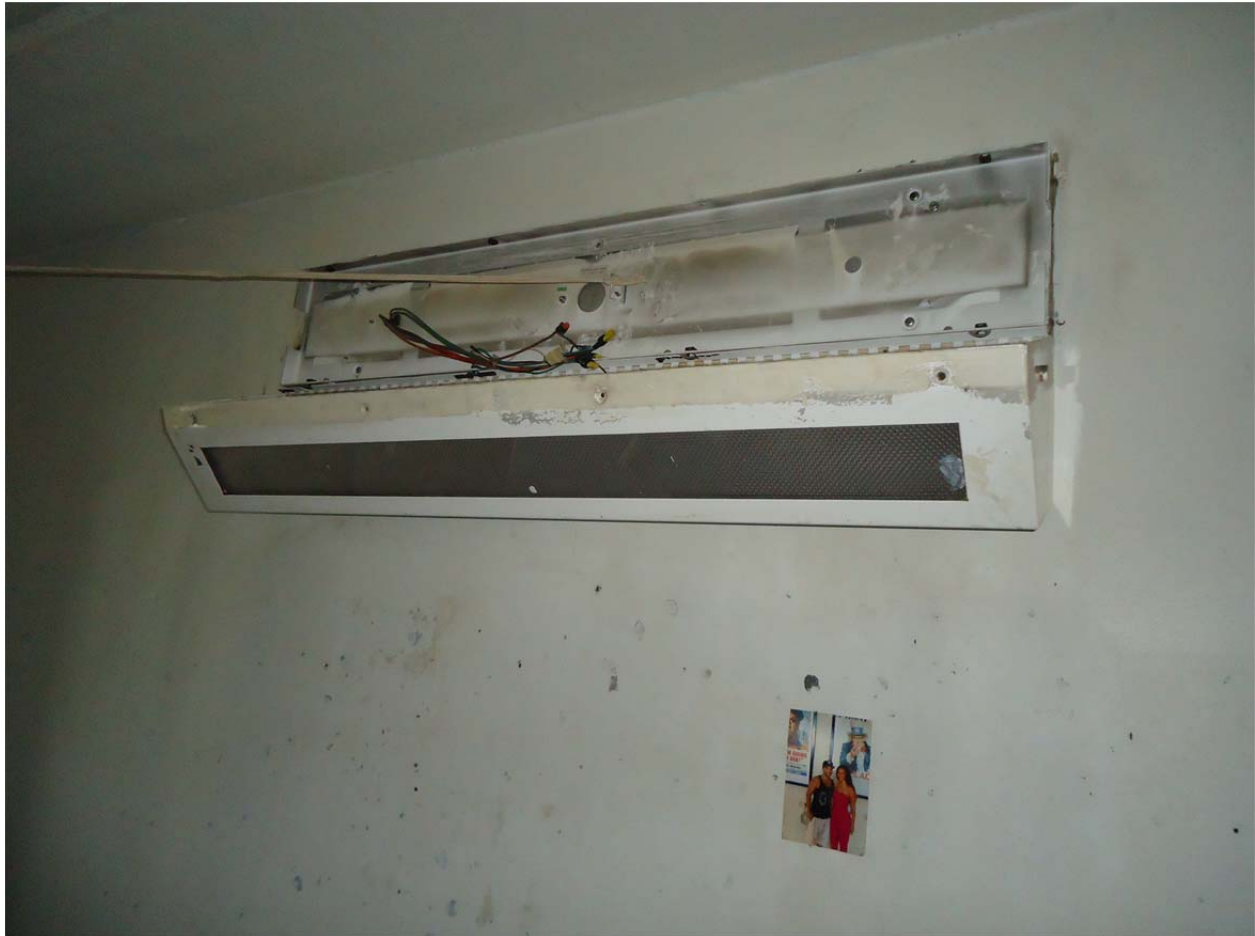
Photo Exhibit: 11

Housing Unit 1A: This photograph depicts the light fixture in cell 1A-105. The fixture has been tampered with, exposing the wiring. Exposed electrical wiring poses a shock hazard. Prisoners can use exposed electrical wiring to light wicks. There was a strong smoke odor in this cell and a burned wick was observed in the toilet as seen in Photo Exhibit 10. Additionally, string was tied around the fire sprinkler head. Tampering with fire detection devices and fire sprinklers places people at risk of fire related injuries, including smoke inhalation and burns.

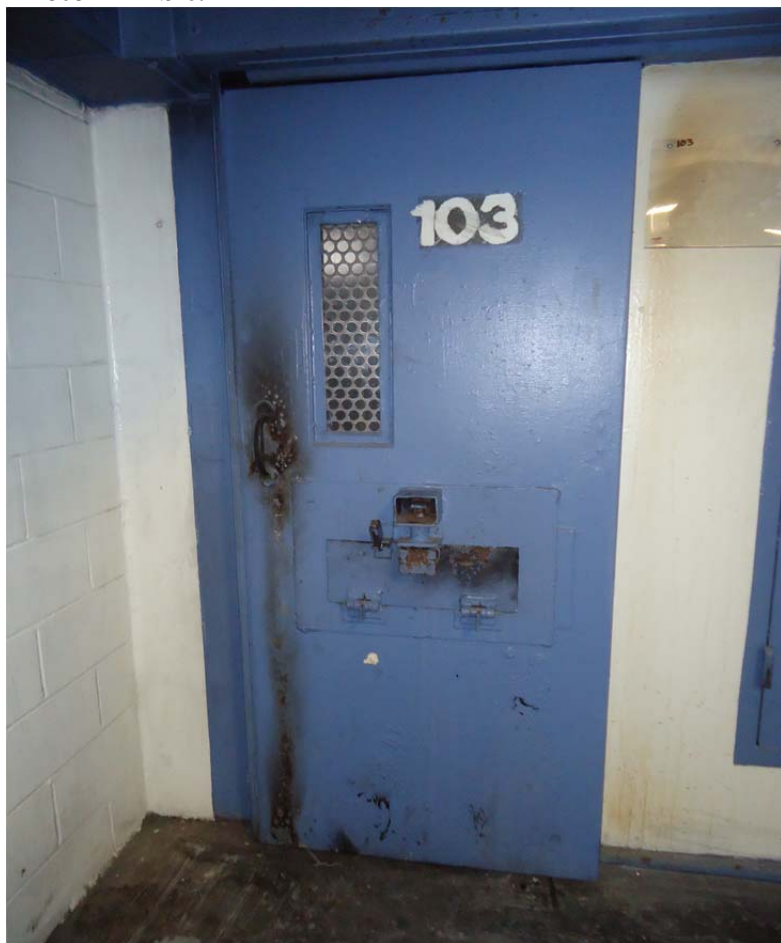
Photo Exhibit: 12

Housing Unit 5A: The scorched areas on the door of cell 103 indicate previous spark or fire incidents. A strong smoke odor was prevalent throughout the housing unit. Smoke and fire in a prison presents a serious danger to both inmates and employees.

Scorched cell doors were observed including 5A-103 (Photo Exhibit 12), 5A-104 (Photo Exhibit 13), 5A-105 (Photo Exhibit 14), 5A-107, 5C-114, and 5C-202. A piece of burned toilet paper was observed on the dayroom floor outside of cells 5A-107 and 108. Evidence of burned paper was observed on the desk in cell 5B-115 and a burned wick was observed in a shallow puddle of water on the floor outside the cell door. Burned tissue was observed outside of 4C-212. Additionally, a strong cigarette smoke odor was noticeable in Unit 4 and ashes that appeared to be from a cigarette were observed in a metal container on a dayroom table in unit 4A.

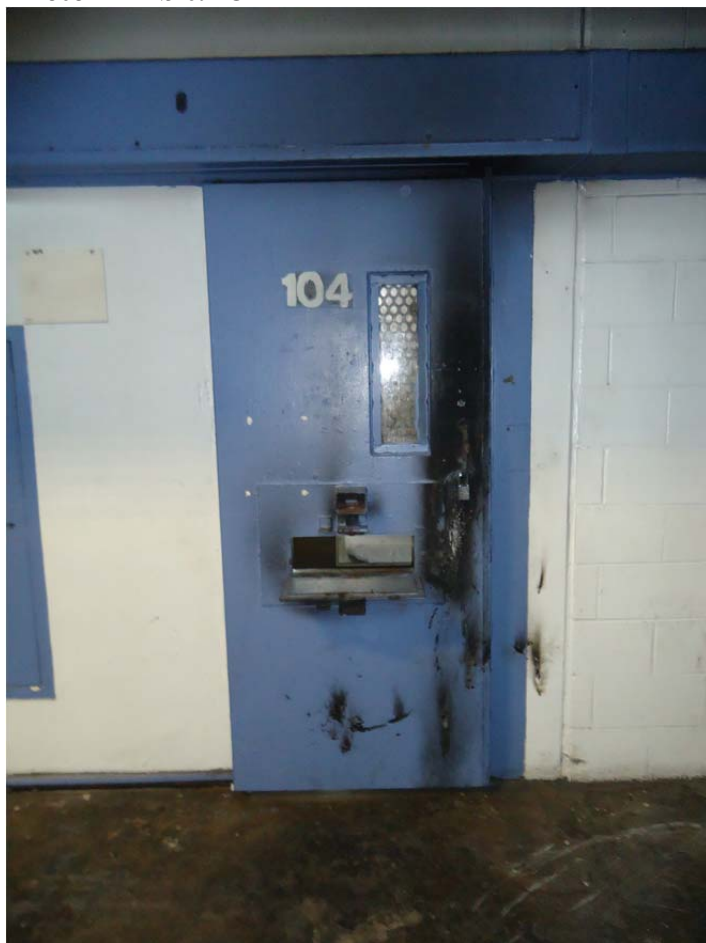
Photo Exhibit: 13

Housing Unit 5A: The photo depicts evidence of previous fire and smoke damage on the door of cell 104. The entire unit smelled strongly of smoke. Fires are particularly dangerous in correctional facilities because of the security-driven limitations on prisoner movement.

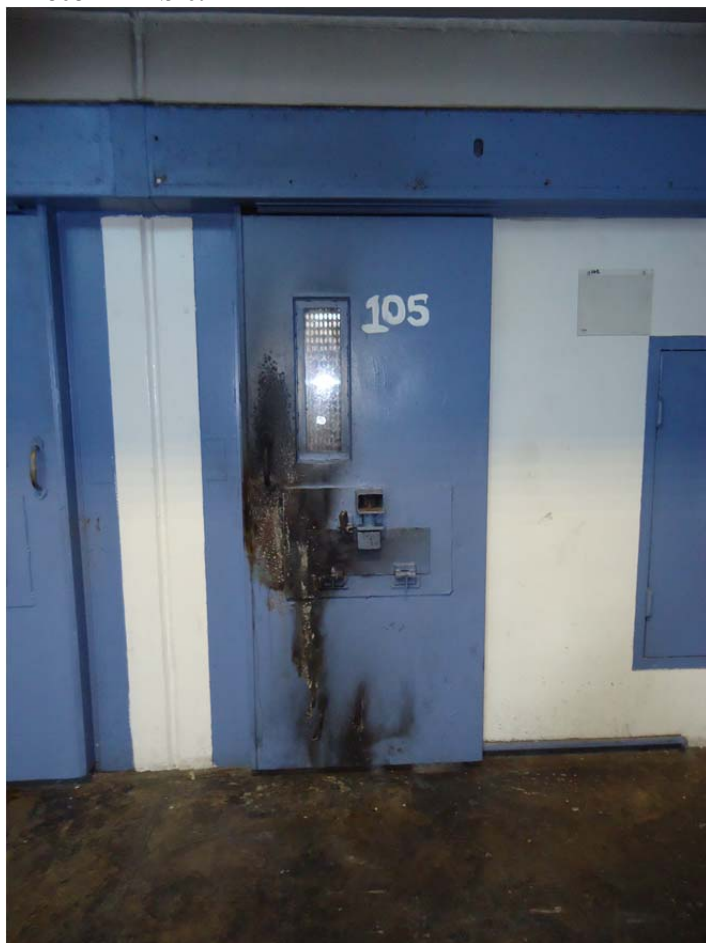
Photo Exhibit: 14

Housing Unit 5A: Photo of previous fire and smoke damage on the door of cell 105. Fire is particularly dangerous in correctional facilities and smoke inhalation is a major cause of fire-related deaths.

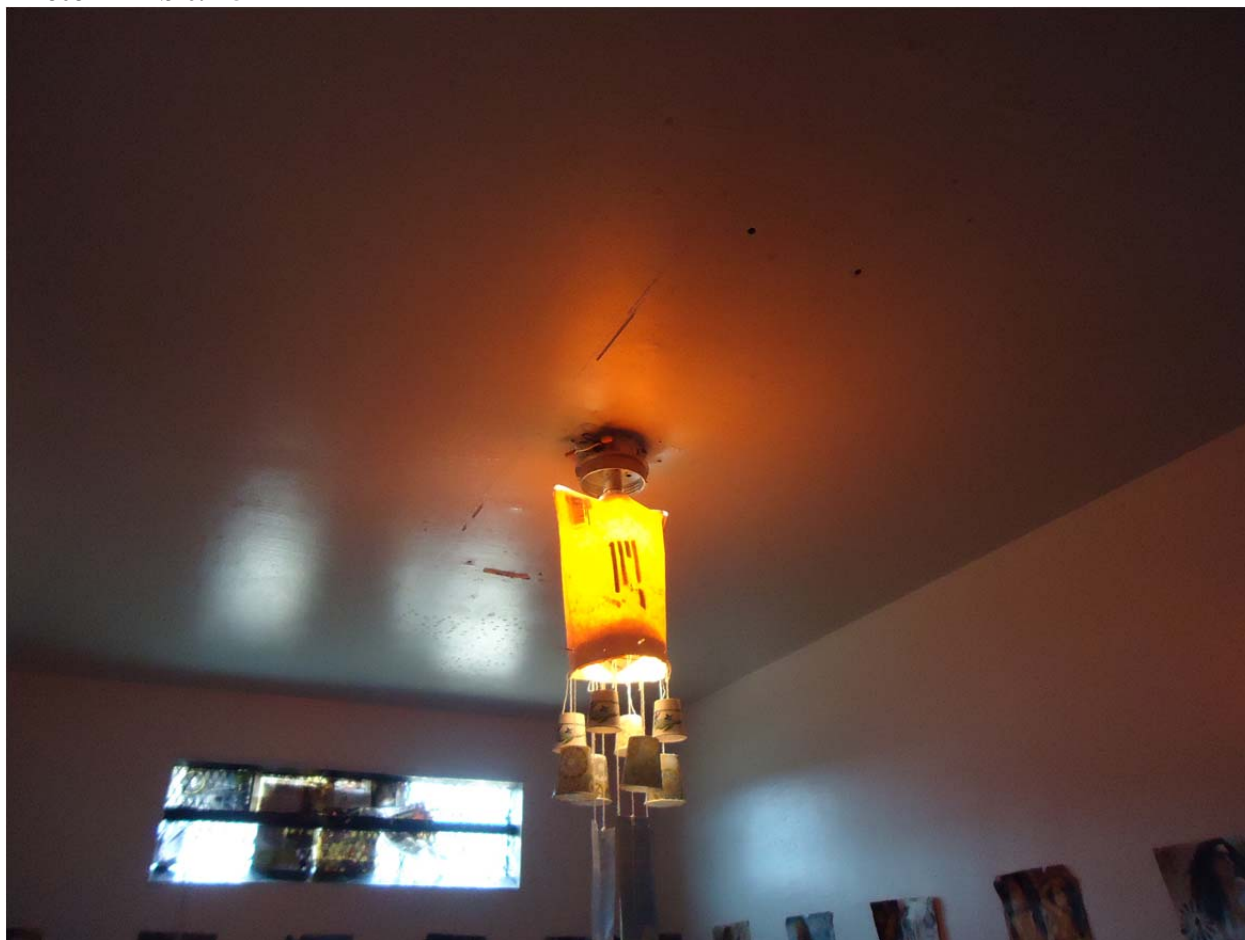
Photo Exhibit: 15

Housing Unit 6D: Picture taken inside a cell in housing unit 6D. The paper envelope resting on the bare light bulb poses a fire hazard.

Placing flammable materials, such as a paper, directly in contact with an unprotected light bulb creates a potential fire hazard. Improvised light fixtures created with paper were observed in 5D-109, 5D-211, 5D-212, 5D-110, 6A-111, 6C-101, 6C-104, 6C-203, 6C-205, 6C-208, 6C-211, 6C-212, and 6D-101 (Photo Exhibit 15).

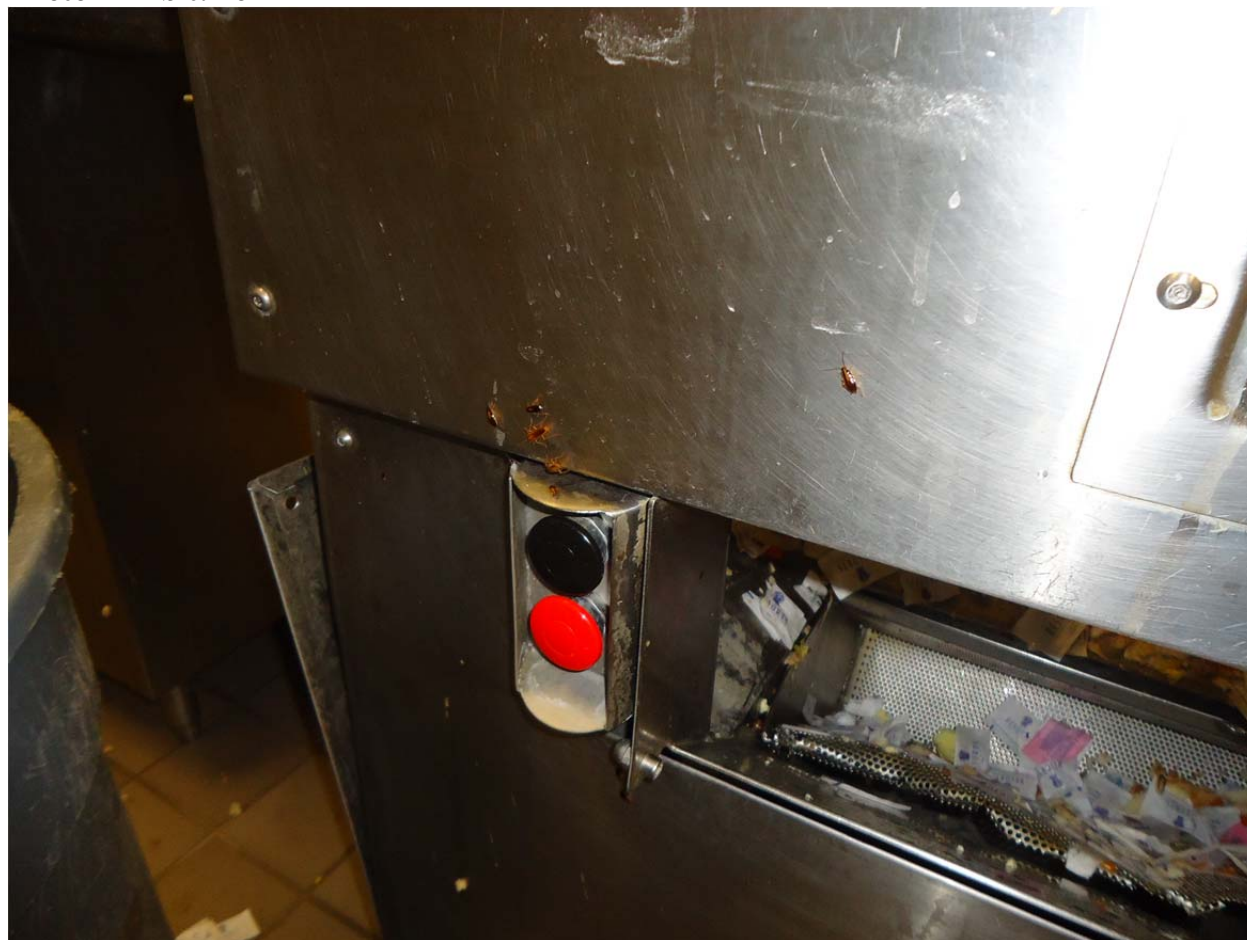
Photo Exhibit: 16

Kitchen: The photo depicts the automatic dishwashing machine in the EMCF kitchen on June 1, 2016. Nymph and adult roaches can be seen emerging out of the cracks and crevices of the dishwasher. Their presence during the well-lit dayshift likely indicates a heavy infestation. More than a dozen roaches were observed. The dishwasher provides a warm, moist environment favored by roaches. Cockroaches are known to carry bacteria that cause food-borne illness, so their presence in the dishwasher is particularly troubling as dishwashers are supposed to clean and sanitize dishes.

Cockroaches, flies, and drain flies were observed in the kitchen on June 1, 2016. Flies and roaches present a health hazard because they can cross contaminate disease-causing microorganisms from dirty surfaces such as the trash or floor to food and clean kitchen surfaces. The presence of roaches in the busy, well-lit kitchen suggests a heavy infestation (see Photo Exhibits 16 and 17).

The low temperature final rinse gauge on the automatic dishwasher did not work and appeared to be broken (Photo Exhibit 22). The 2013 FDA Food Code requires that ware washing machines be equipped with operable devices that measure the temperatures of the washing, rinsing, and sanitizing water. Furthermore, it is important to maintain and operate dish washing machines in accordance with the temperatures specified on the manufacturer's data plate. Sanitizing dishes in the automatic dishwasher is critically important because proper sanitization results in a 99.999% reduction of disease-causing microorganisms. In this case, adherence to the required cleaning and sanitizing temperatures is imperative because this dishwasher is infested with cockroaches as depicted in Photo Exhibits 16 and 17.

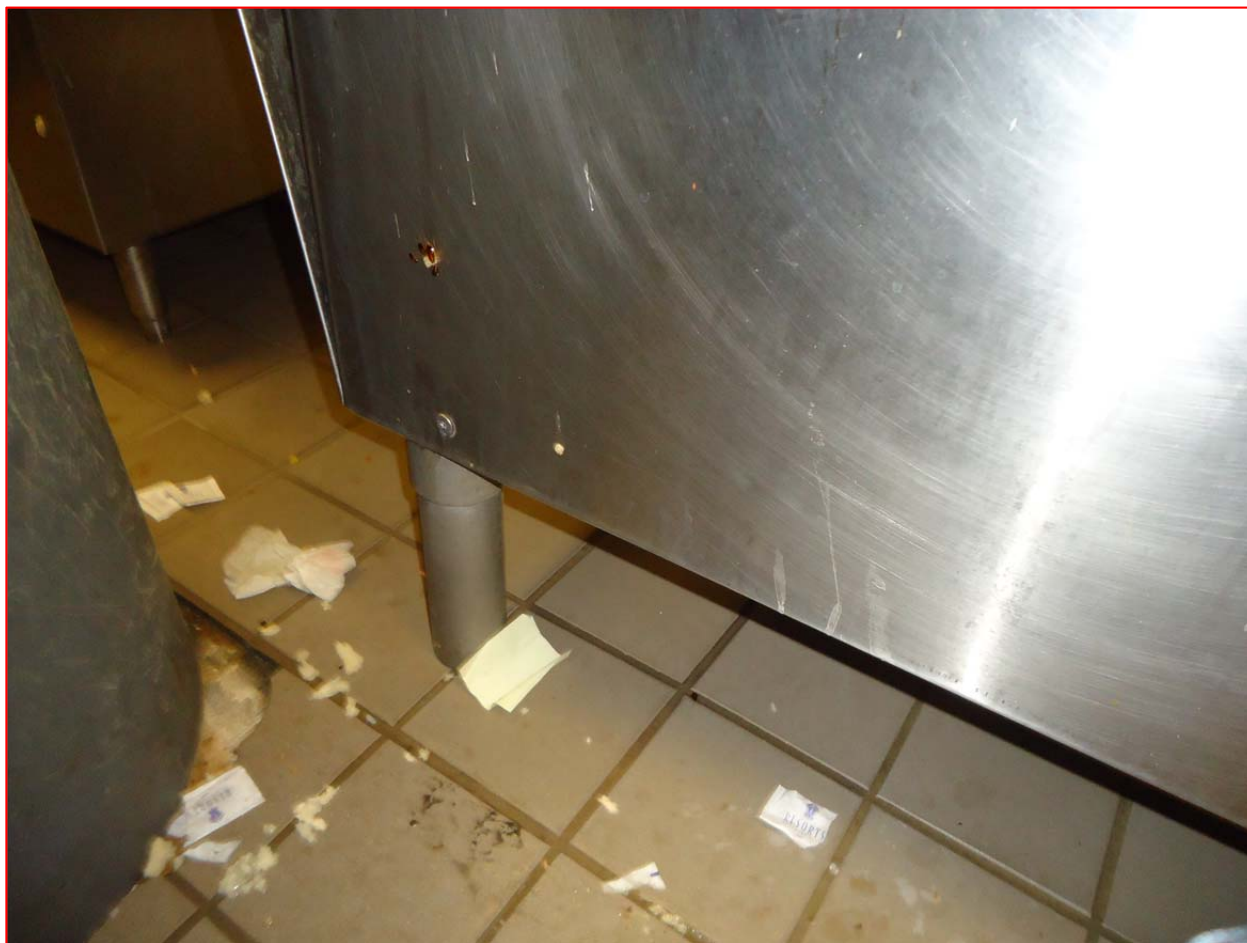
Photo Exhibit: 17

Kitchen: The photo depicts the lower side of the automatic dishwashing machine in the kitchen. A group of roaches can be seen above the leg of the machine. The photo also captures a small portion of a large area of missing and broken floor tiles underneath a plastic trashcan on the left side of the picture.

Large areas of floor tiles were observed to be broken and missing in the dishwashing area (Photo Exhibit 17) and the cooking area (Photo Exhibit 23). The exposed flooring underneath the missing tiles is rough, rendering it difficult to clean. Although food should not come in direct contact with the floor, the 2013 FDA Food Code requires that floors be designed, constructed, and installed in such a manner that they are smooth and easily cleanable. The kitchen, including the floor must be maintained in good repair to facilitate the high level of cleanliness necessary to reduce or eliminate microbial and mold growths and prevent food borne illness outbreaks.
