Environmental Health Inspections
East Mississippi Correctional Facility
Meridian, Mississippi
June 1, 2016 through June 2, 2016

December 19, 2016

Prepared by:
Diane Skipworth, MCJ, R.D., L.D., R.S., CCHP, CLLM

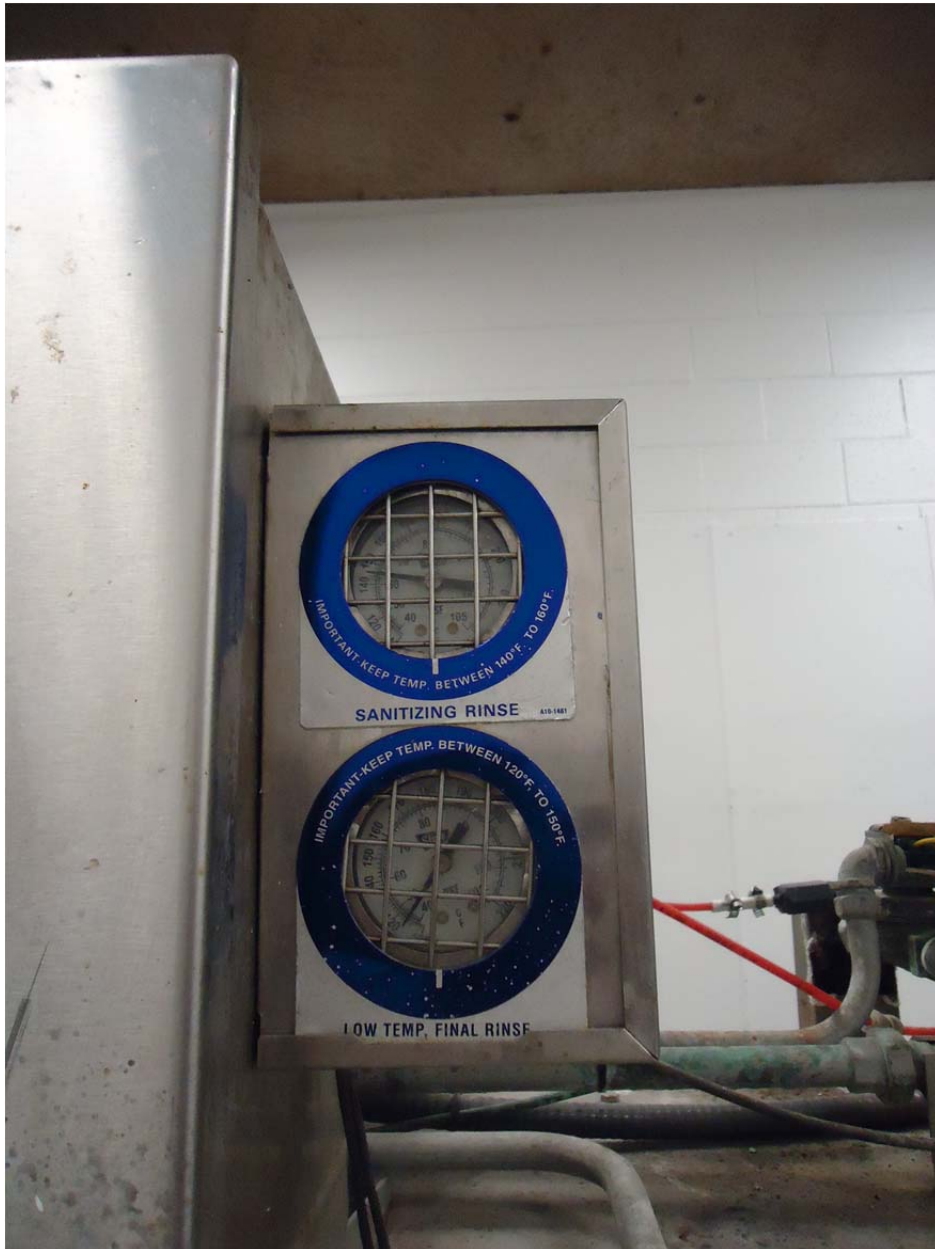
Photo Exhibit: 22

Dishwasher Temperature Gauges in Kitchen: The upper “Sanitizing Rinse” gauge appears to be working and is within the manufacturer’s specified temperature range. However, the lower “Low Temp Final Rinse” Gauge was not registering and appeared to be broken. Therefore, it cannot be established that the final rinse water temperature met the standards specified for the machine. Dishwashers should be operated in accordance with the information found on the manufacturer’s data plate. Proper cleaning and sanitizing of dishes is important to prevent the spread of food borne illnesses.

The low temperature final rinse gauge on the automatic dishwasher did not work and appeared to be broken (Photo Exhibit 22). The 2013 FDA Food Code requires that ware washing machines be equipped with operable devices that measure the temperatures of the washing, rinsing, and sanitizing water. Furthermore, it is important to maintain and operate dish washing machines in accordance with the temperatures specified on the manufacturer's data plate. Sanitizing dishes in the automatic dishwasher is critically important because proper sanitization results in a 99.999% reduction of disease-causing microorganisms. In this case, adherence to the required cleaning and sanitizing temperatures is imperative because this dishwasher is infested with cockroaches as depicted in Photo Exhibits 16 and 17.

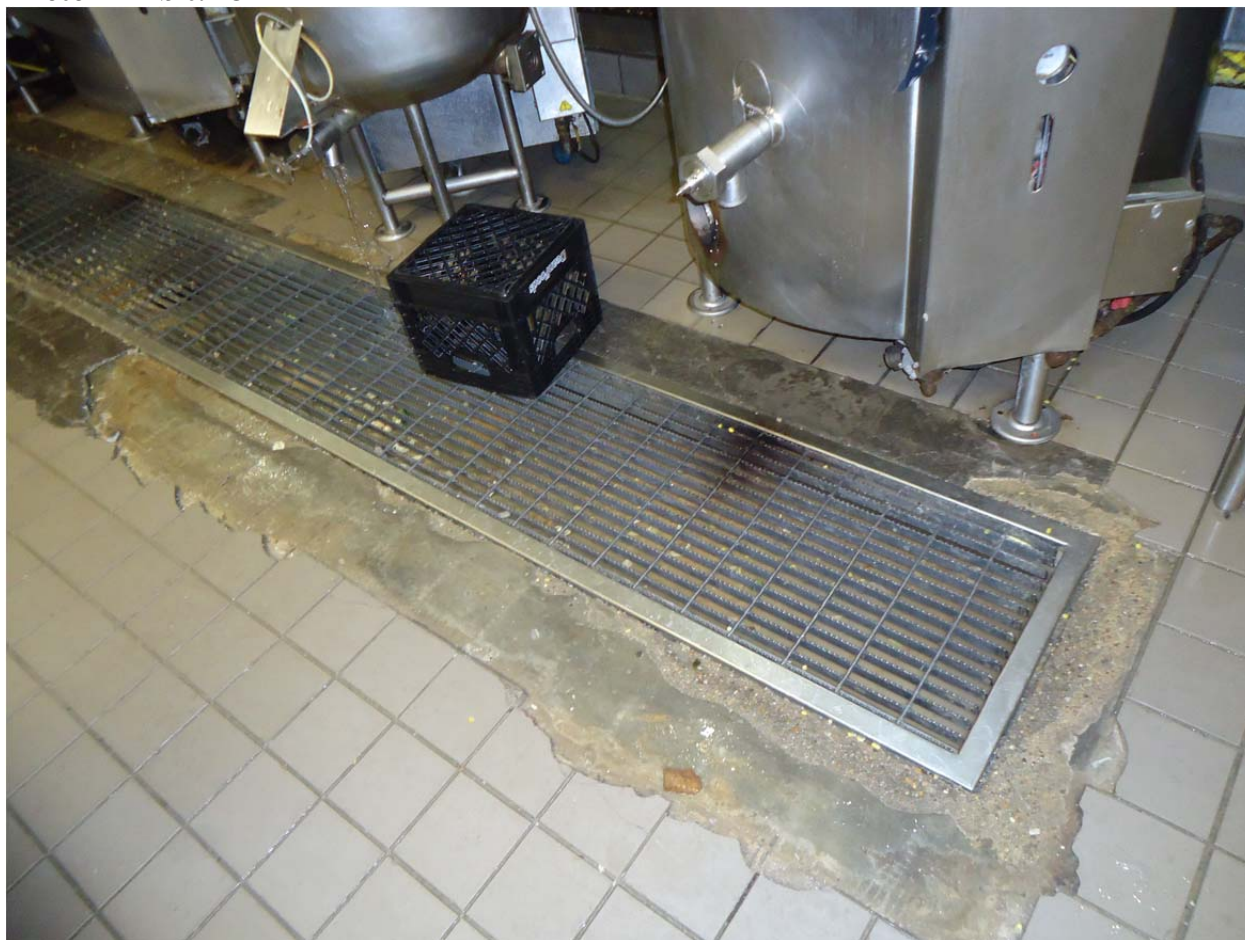
Photo Exhibit: 23

Kitchen: Missing and broken floor tiles under the cooking kettles. The condition of the floor violates the 2013 FDA Food Code that requires floor surfaces be smooth and easily cleanable to facilitate the high level of sanitation required in a kitchen to prevent food-borne illnesses.

Large areas of floor tiles were observed to be broken and missing in the dishwashing area (Photo Exhibit 17) and the cooking area (Photo Exhibit 23). The exposed flooring underneath the missing tiles is rough, rendering it difficult to clean. Although food should not come in direct contact with the floor, the 2013 FDA Food Code requires that floors be designed, constructed, and installed in such a manner that they are smooth and easily cleanable. The kitchen, including the floor must be maintained in good repair to facilitate the high level of cleanliness necessary to reduce or eliminate microbial and mold growths and prevent food borne illness outbreaks.

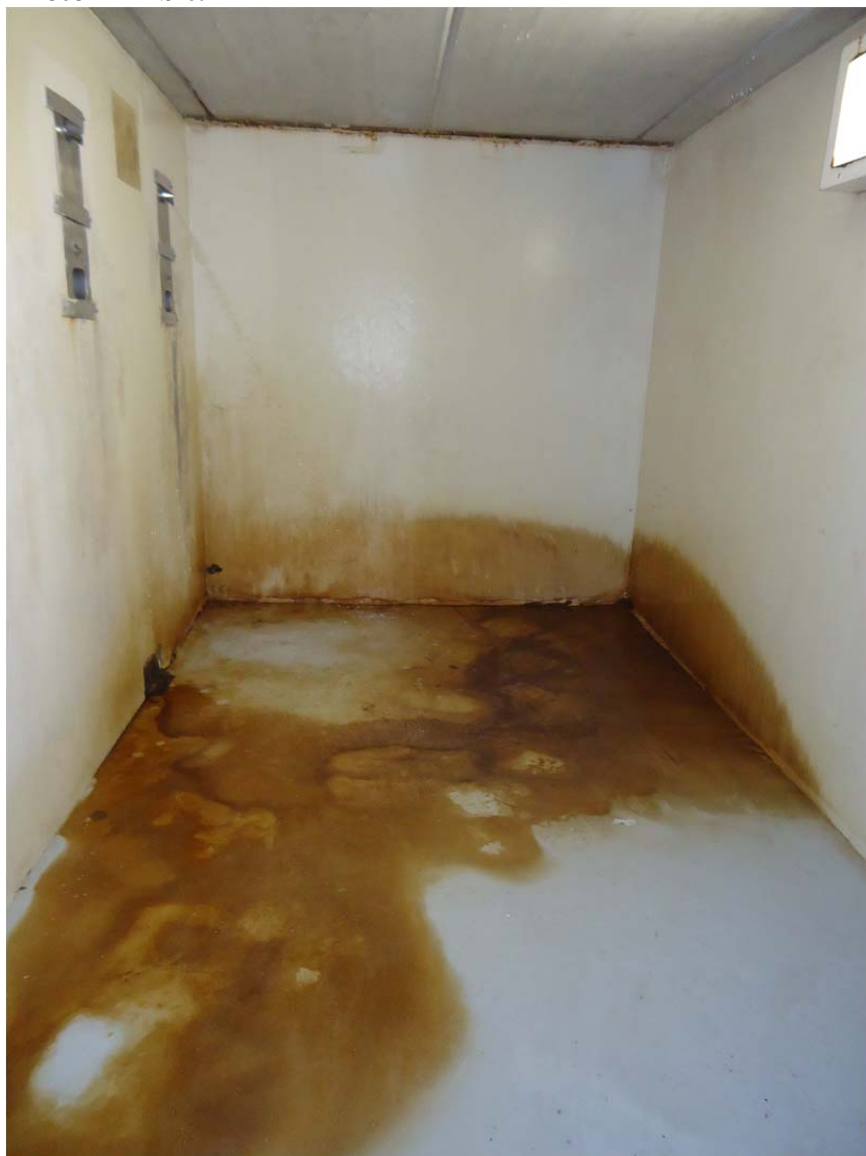
Photo Exhibit: 24

Housing Unit 2C: The photo depicts the upper shower room in housing unit 2C. The discoloration appears to be rust from the metal shower that is bleeding through the painted surface. The condition of the shower is not conducive to good personal hygiene.

Personal hygiene areas, including the shower stalls and shower rooms must be kept in good repair, clean, and routinely disinfected to prevent the spread of disease and fungal infections such as ringworm. The 2C upper showers (Photo Exhibit 24), 3A lower showers, and 3C lower showers (Photo Exhibit 25) are severely discolored by what appears to be rust from the metal shower walls bleeding through the painted surface.

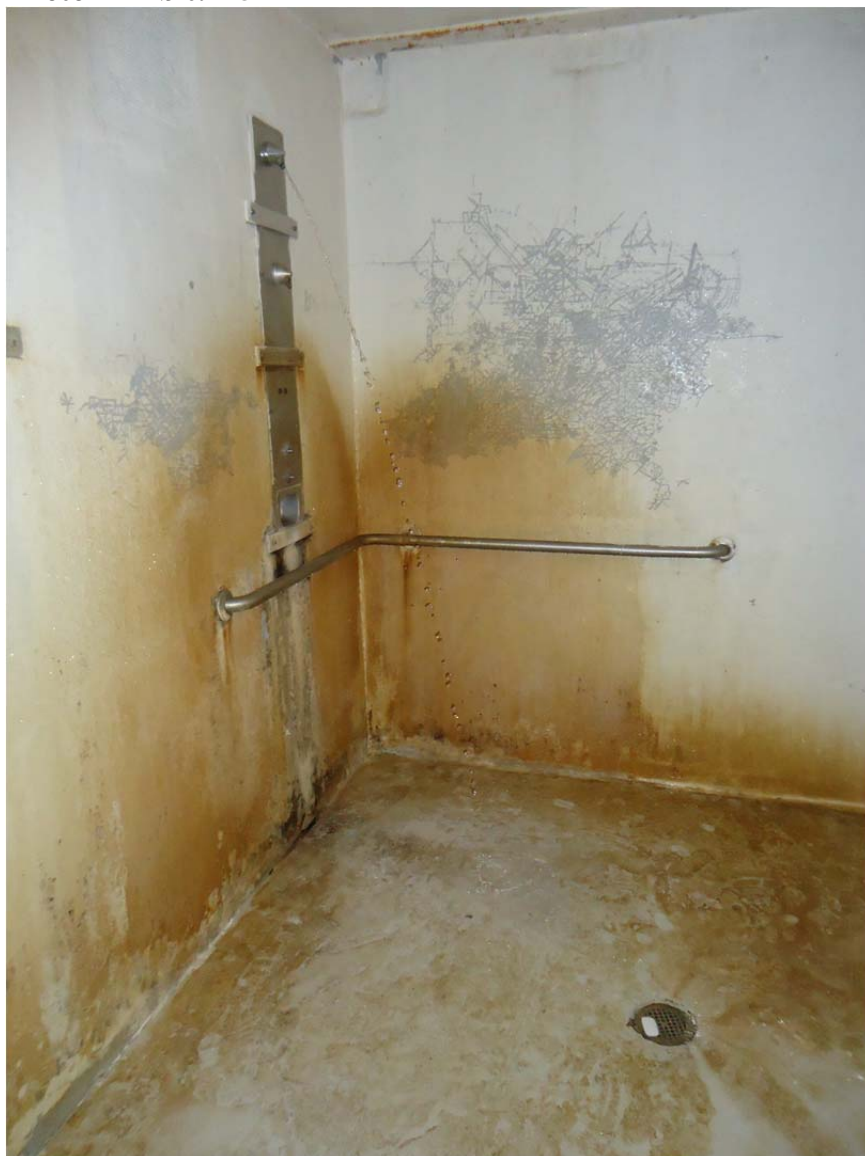
Photo Exhibit: 25

Housing Unit 3C: This photograph shows the condition of the lower shower room in housing unit 3C. The discoloration appears to be rust from the metal shower that is bleeding through the painted surface. The rust, scratched paint, and apparent mildew growths below the showerheads create an unhygienic environment that poses an impediment to showering and good personal hygiene practices.

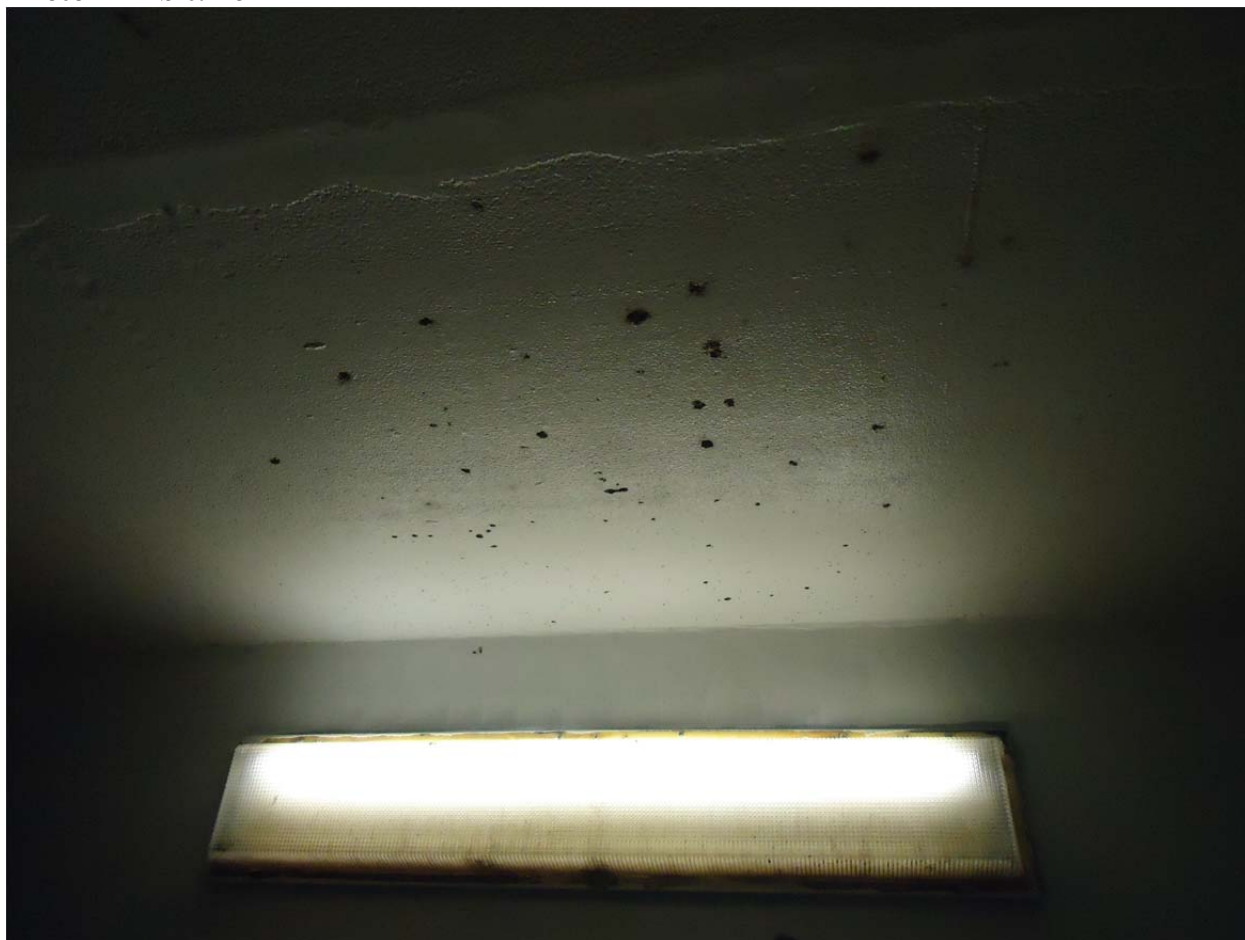
Photo Exhibit: 26

Housing Unit 3C: Picture of apparent mold growths on the ceiling of the lower shower room in housing unit 3C. Although mold growths are not toxic or poisonous, exposure may produce upper respiratory tract symptoms such as coughs, especially in those with chronic respiratory disease. Furthermore, exposure poses an increased risk of infection in immunosuppressed individuals.

Molds are fungi that grow in damp, warm, humid conditions. Apparent mold growths were observed in the 1A lower showers, 1D lower and upper showers, 2D upper showers, 3A lower and upper showers, and 3C lower showers (Photo Exhibit 26). Although mold growths are not toxic or poisonous, exposure to mold may produce upper respiratory tract symptoms such as coughs, especially in those with chronic respiratory disease. Furthermore, mold exposure poses an increased risk of infection in immunosuppressed individuals.

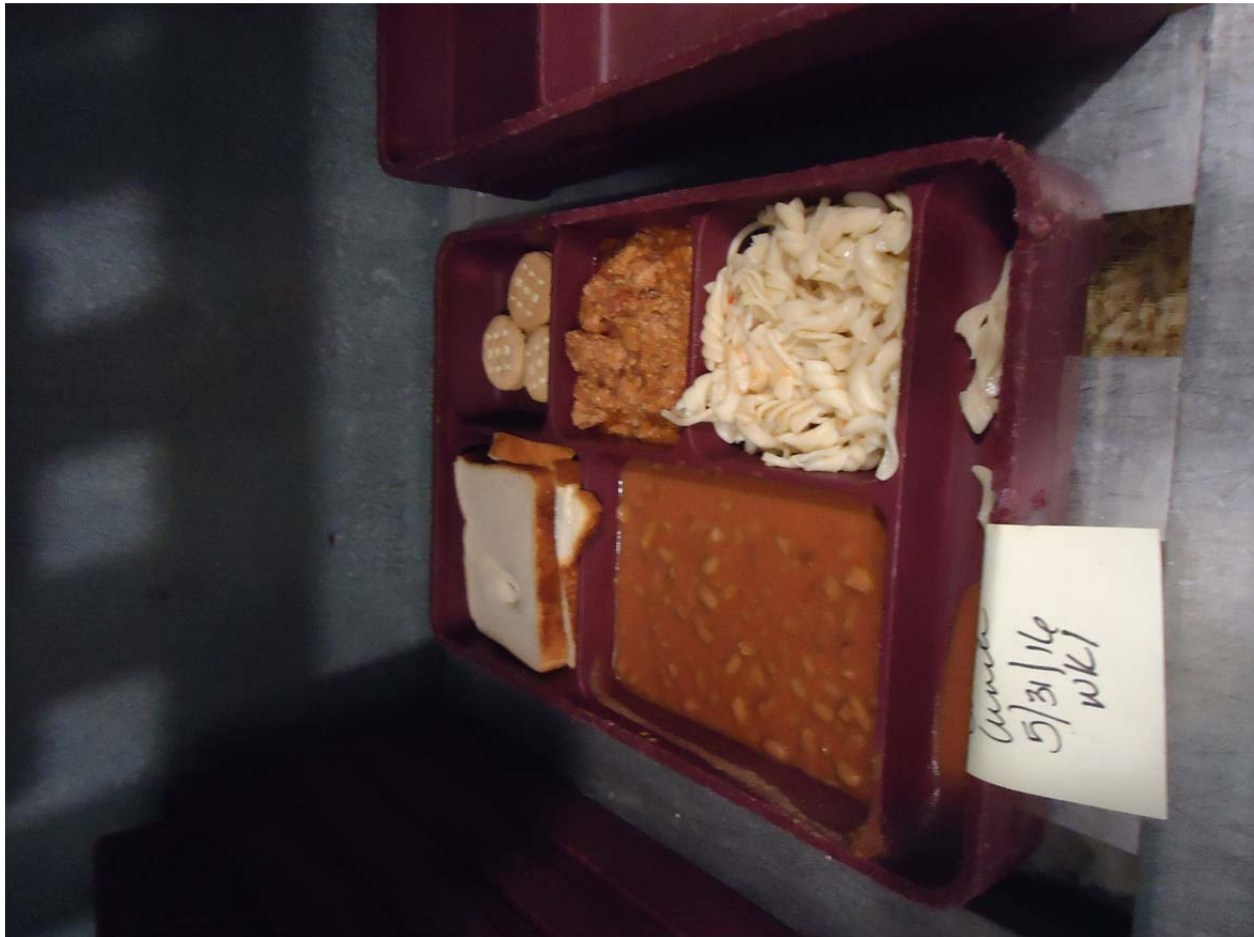
Photo Exhibit: 27

Meal Tray: Picture of labeled meal tray that was taken inside a refrigerator in the EMCF kitchen. The label on the tray indicates that it is a sample tray for 5/31/16 lunch meal. The menu provided by the defendants and the posted menu (see Photo Exhibit 18) indicate that the Regular, Week 1, Tuesday meal is supposed to consist of “sloppy Joe, hamburger bun, black eyed peas, pasta salad, glazed cake, and beverage packet.” However, three out of the six menu items deviate from the dietitian approved menu plan, as sliced bread appears to be served in place of the hamburger bun, pinto beans in place of the black eyed peas, and cookies in place of the glazed cake. Failure to adhere to a dietitian-approved menu places prisoners at risk of under-nutrition and weight loss. Furthermore, failure to serve meals in accordance with the posted menu often causes prisoners to distrust the food service operation.

Furthermore, prisoners allege that the actual meals served at EMCF do not correspond with the posted menus and my observation of meal trays confirms this allegation (Photo Exhibits 27 and 28). Failure to adhere to the dietitian-approved menu places prisoners at risk of under-nutrition and weight loss. Furthermore, failure to serve meals in accordance with the posted menu often causes distrust of the food service operation, which can lead to low morale and adversely impact the overall atmosphere of the facility.

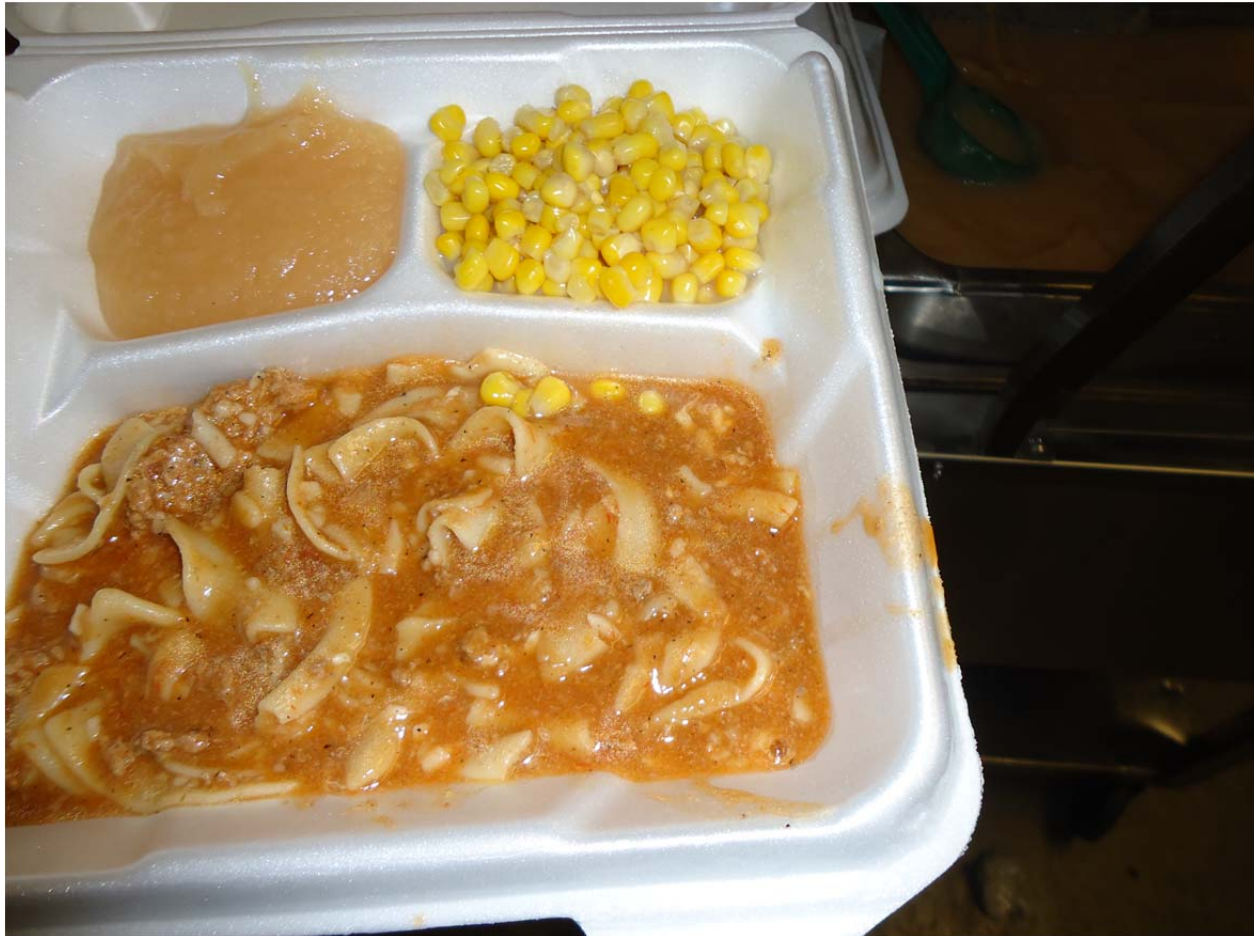
Photo Exhibit: 28

Meal Tray: Picture of a random lunch meal tray that was taken on June 1, 2016, in the Unit 5/6 vestibule during the lunch meal service. The menu provided by the defendants and the posted menu (see Photo Exhibit 18) indicate that the Regular, Week 1, Wednesday meal is supposed to consist of “lasagna casserole, carrots, tossed salad, Italian dressing, roll, margarine, apple sliced, and beverage packet.” A roll with margarine was also served, however, it is not shown in this photograph. The observed meal reveals that corn was apparently served in place of carrots and applesauce was served in place of the sliced apple. Additionally, the tossed salad with Italian dressing was not observed being served. Failure to adhere to the dietitian-approved menu places prisoners at risk of under-nutrition and weight loss. Furthermore, failure to serve meals in accordance with the posted menu often causes distrust of the food service operation.
